CONSTRUCTION STORMWATER GENERAL PERMIT INSPECTION REPORT

State of Washington Department of Ecology

The Electron Hydro LLC Intake project is covered under the State of Washington's Construction Stormwater General Permit (CSWGP). The CSWGP is a National Pollutant Discharge Elimination System (NPDES) and a State Waste Discharge permit for discharge of construction-related stormwater. The purpose of this inspection was to conduct a compliance inspection with Ecology's new staff, Evan Wood, to provide technical assistance as appropriate, and to continue to make site observations and have discussions regarding the water quality management plan (WQMP). The settling basin and forebay/laydown areas were also viewed, which are not within or near the CSWGP site, but has implications related to hydro operations and sediment management. Follow-up is occurring outside of the CSWGP.

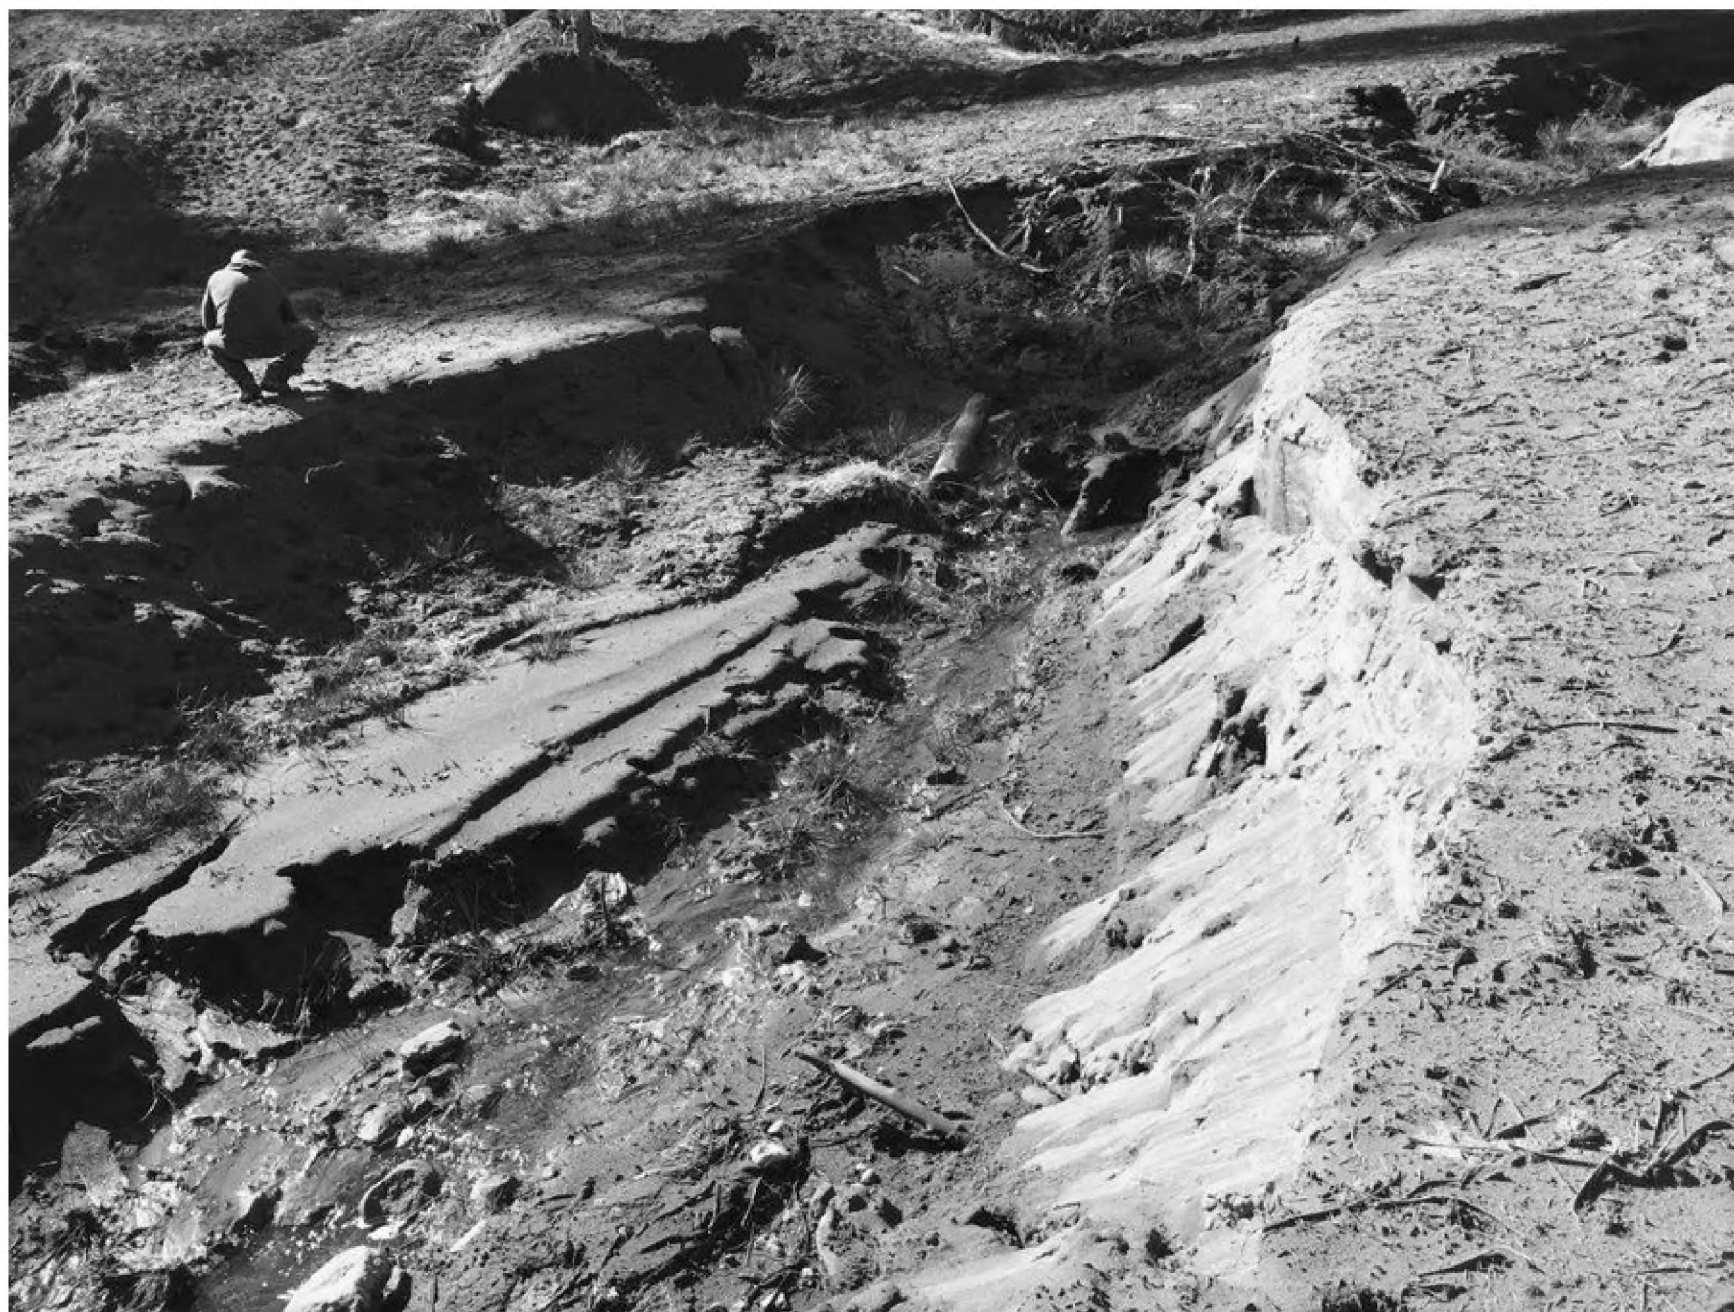
Photo 10

Photo Description: Settling Basin area – section of the landslide that has eroded away. This is a section where sediment deposits from the landslide have been carried downstream via a creek that empties into Puyallup River. Electron's stabilization and restoration ideas were discussed.

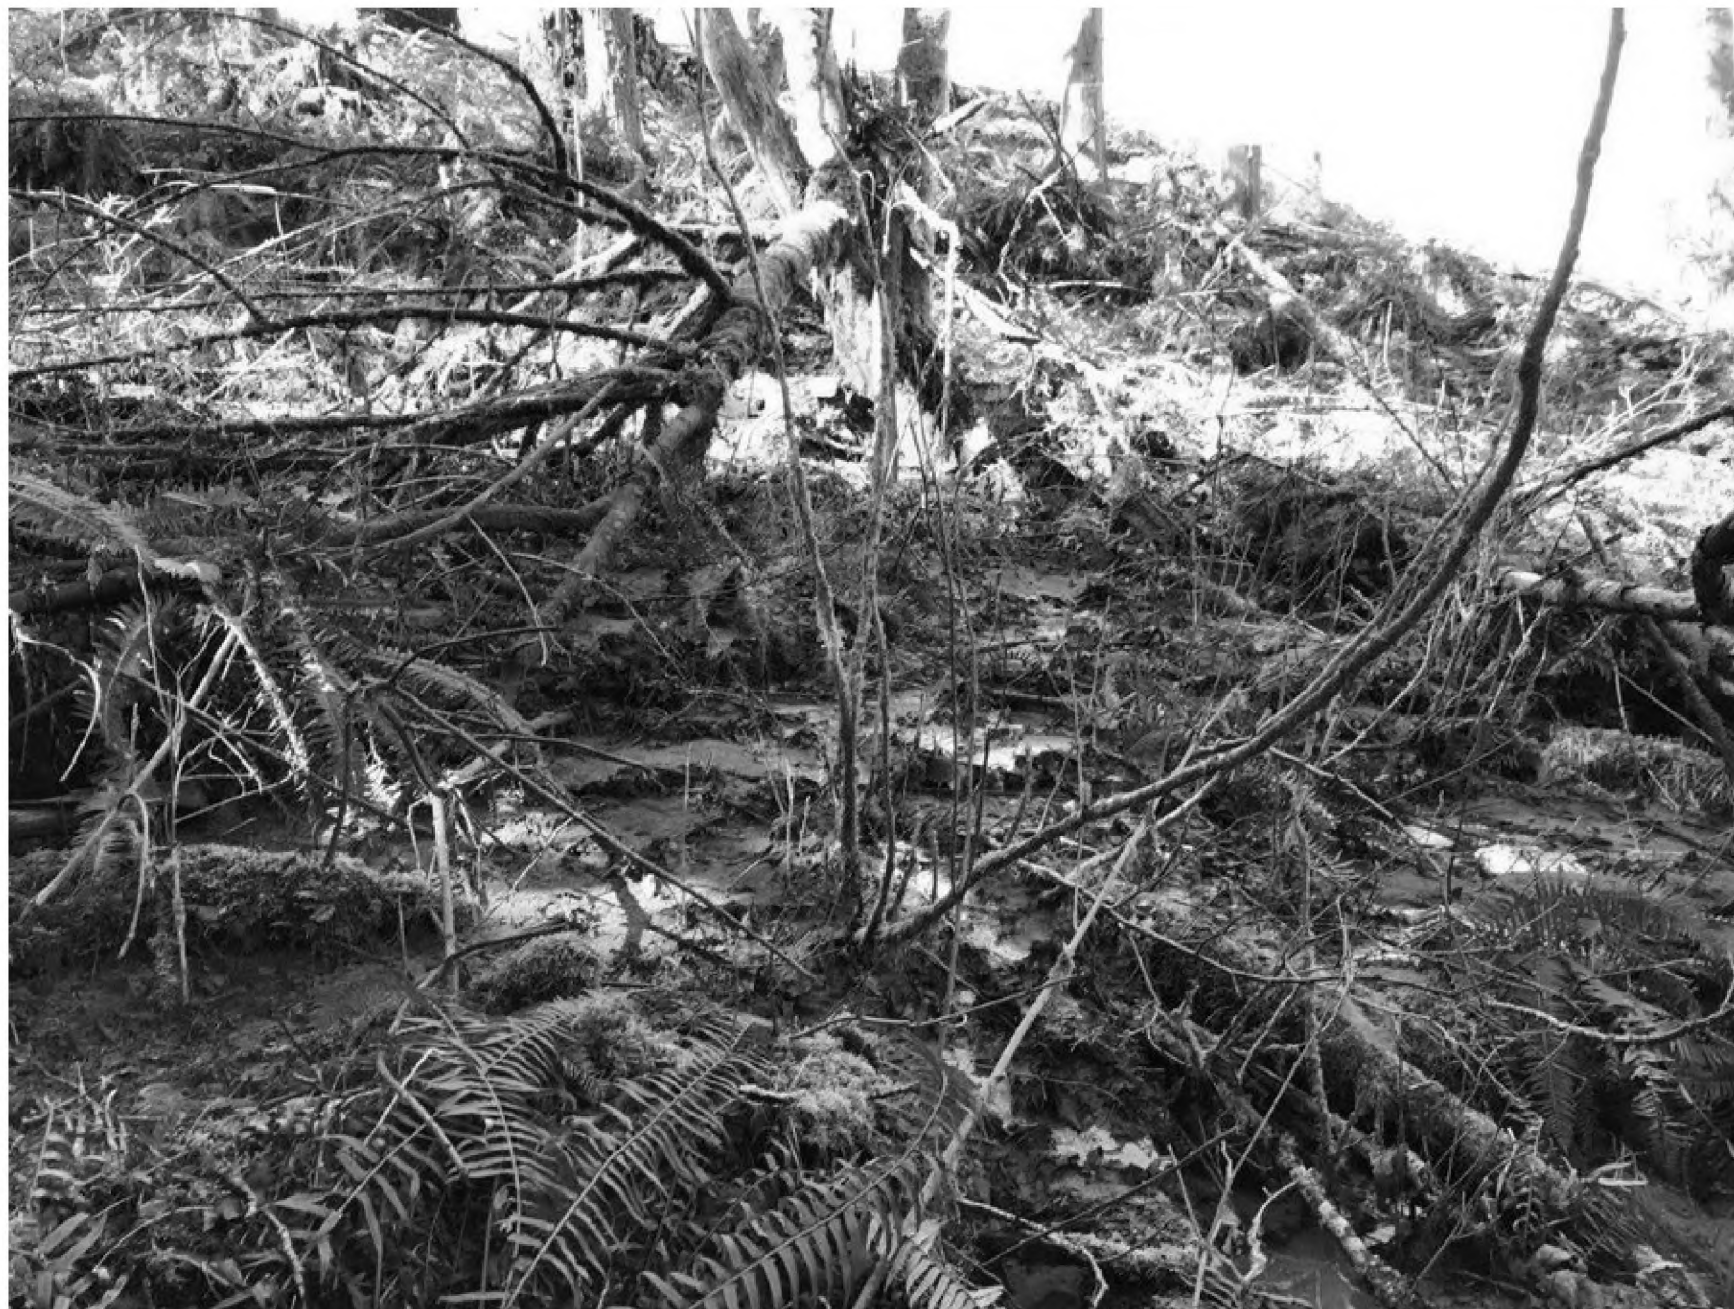
Photo 11

Photo Description: : Settling Basin area – landslide sediments carried along the creek

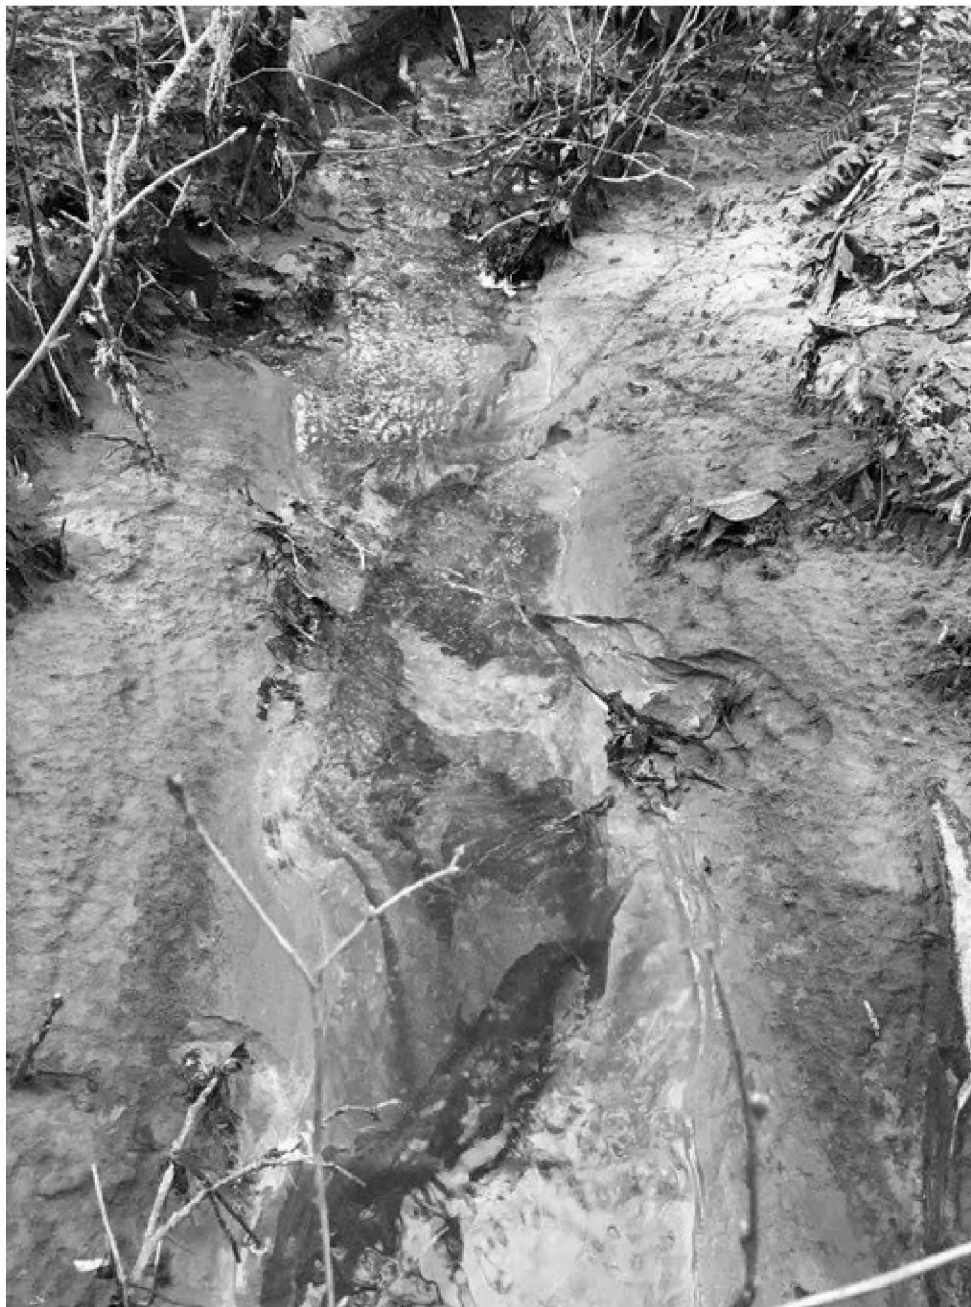
Photo 12

Photo Description: Settling Basin area – landslide sediments carried along the creek

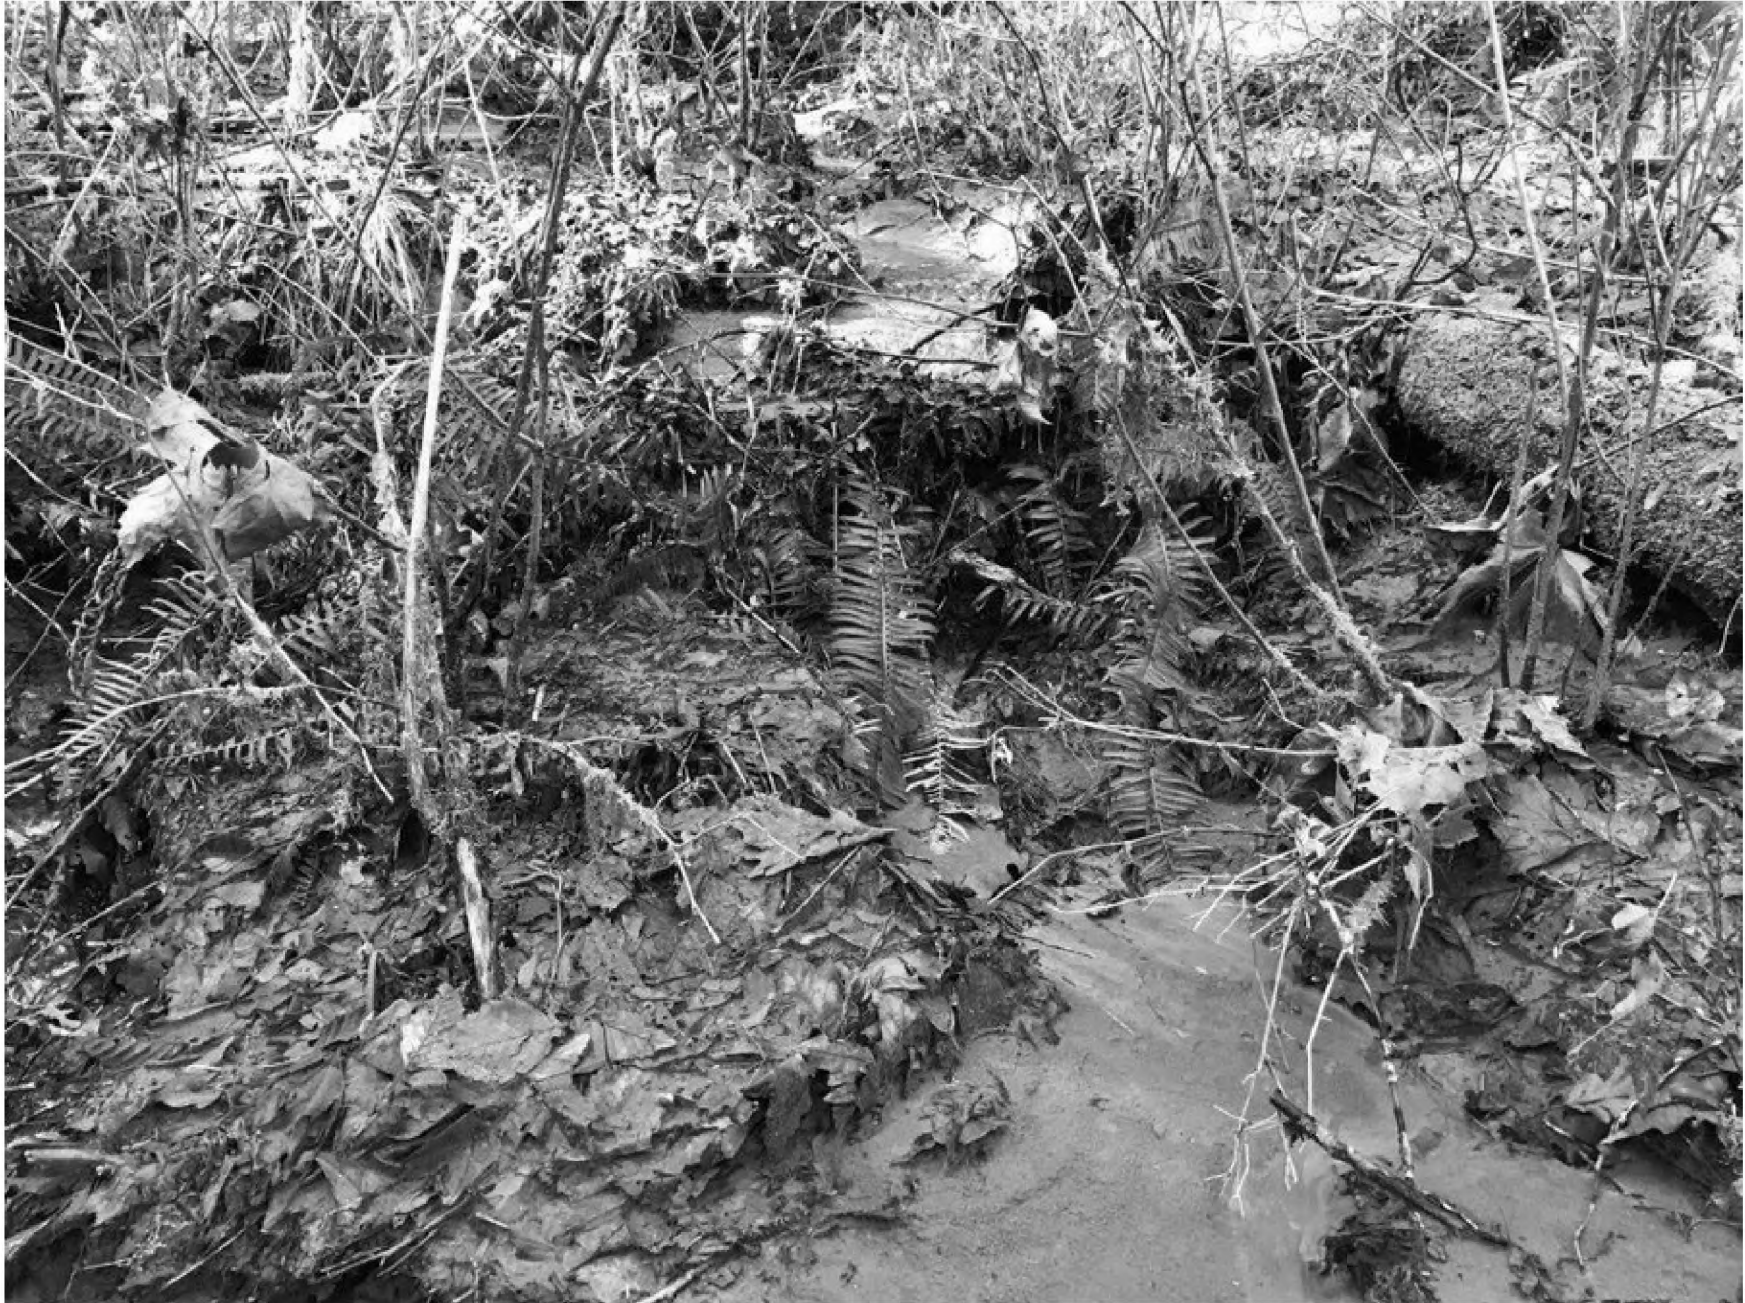
Photo 13

Photo Description: Settling Basin area – landslide sediments carried along the creek

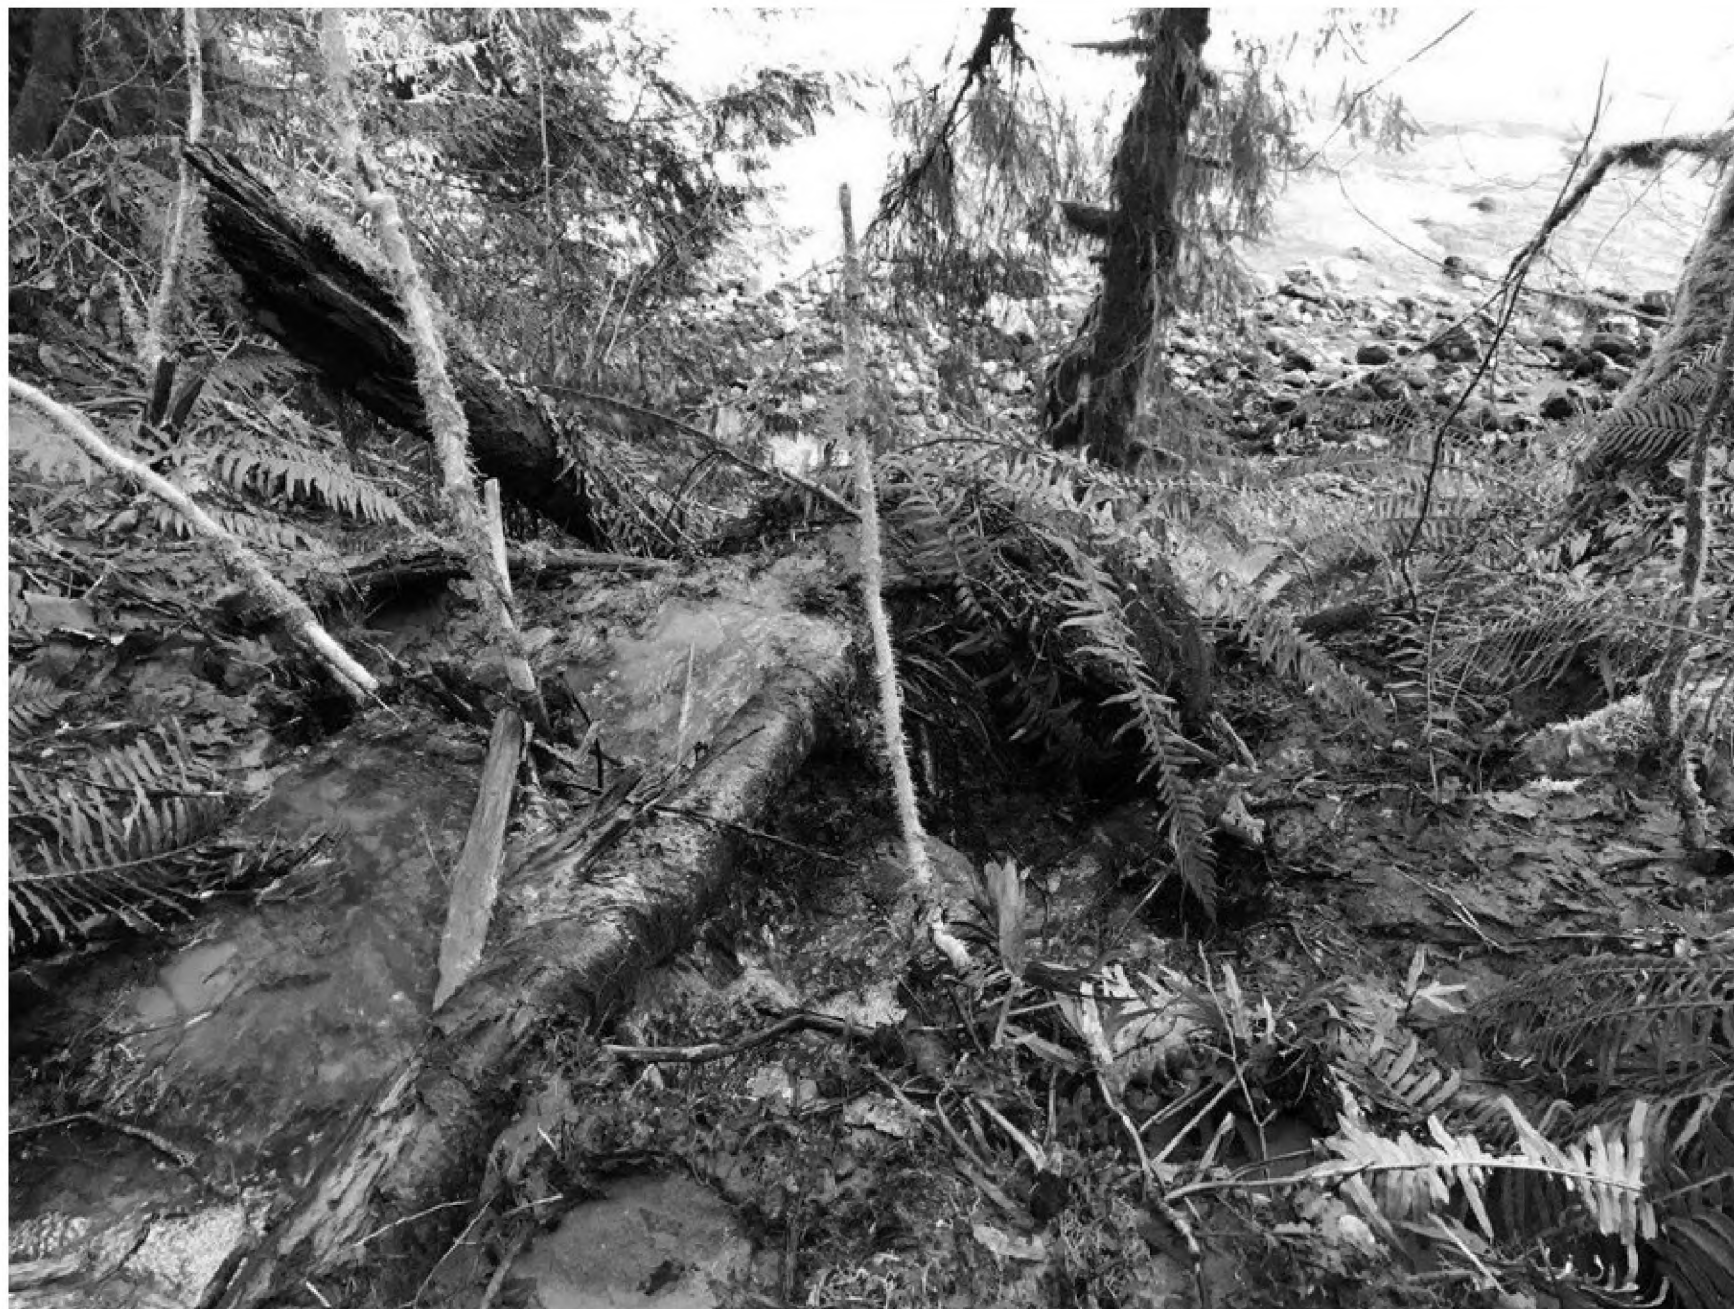
Photo 14

Photo Description: Settling Basin area – landslide sediments carried along the creek and over the embankment into the Puyallup River

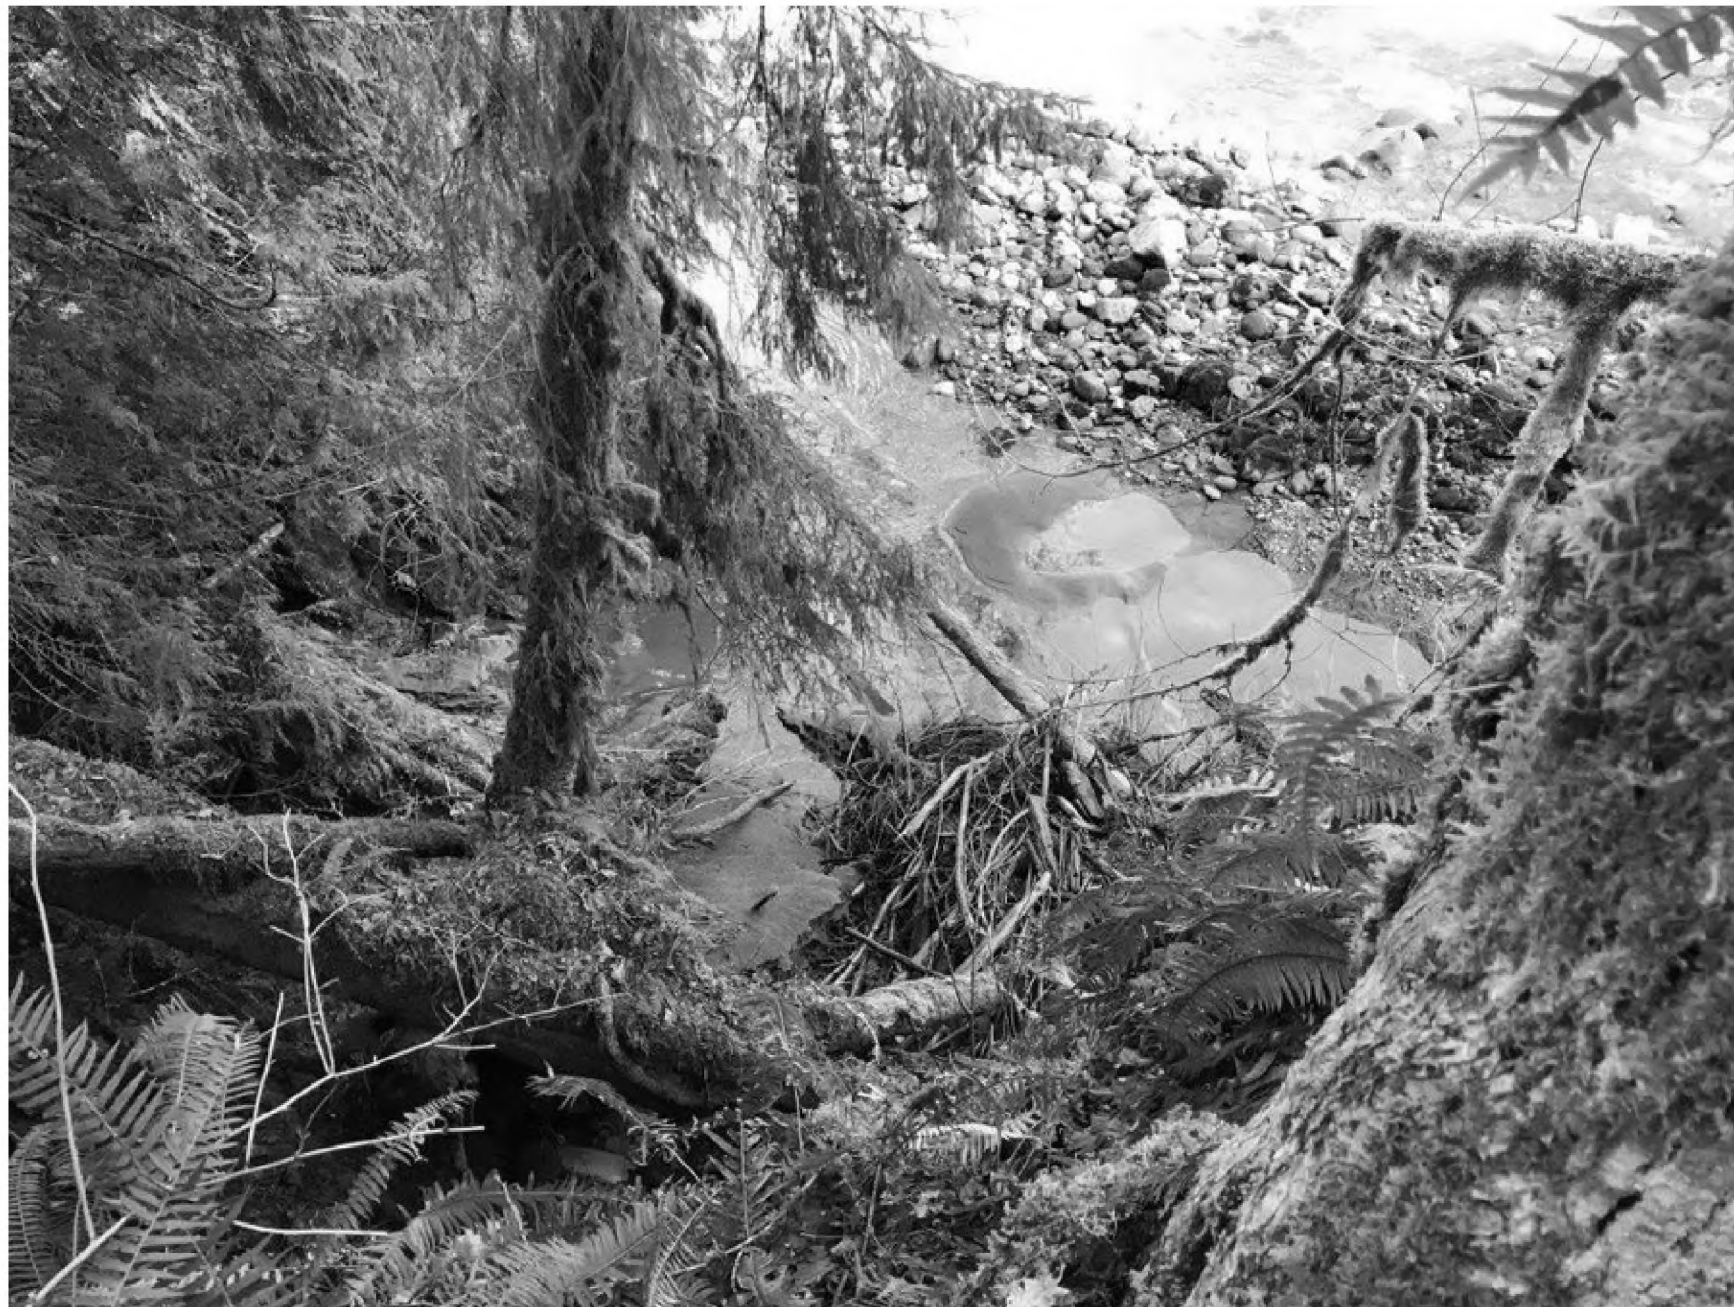
Photo 15

Photo Description: Settling Basin area – landslide sediments deposited onto the Puyallup riverbed

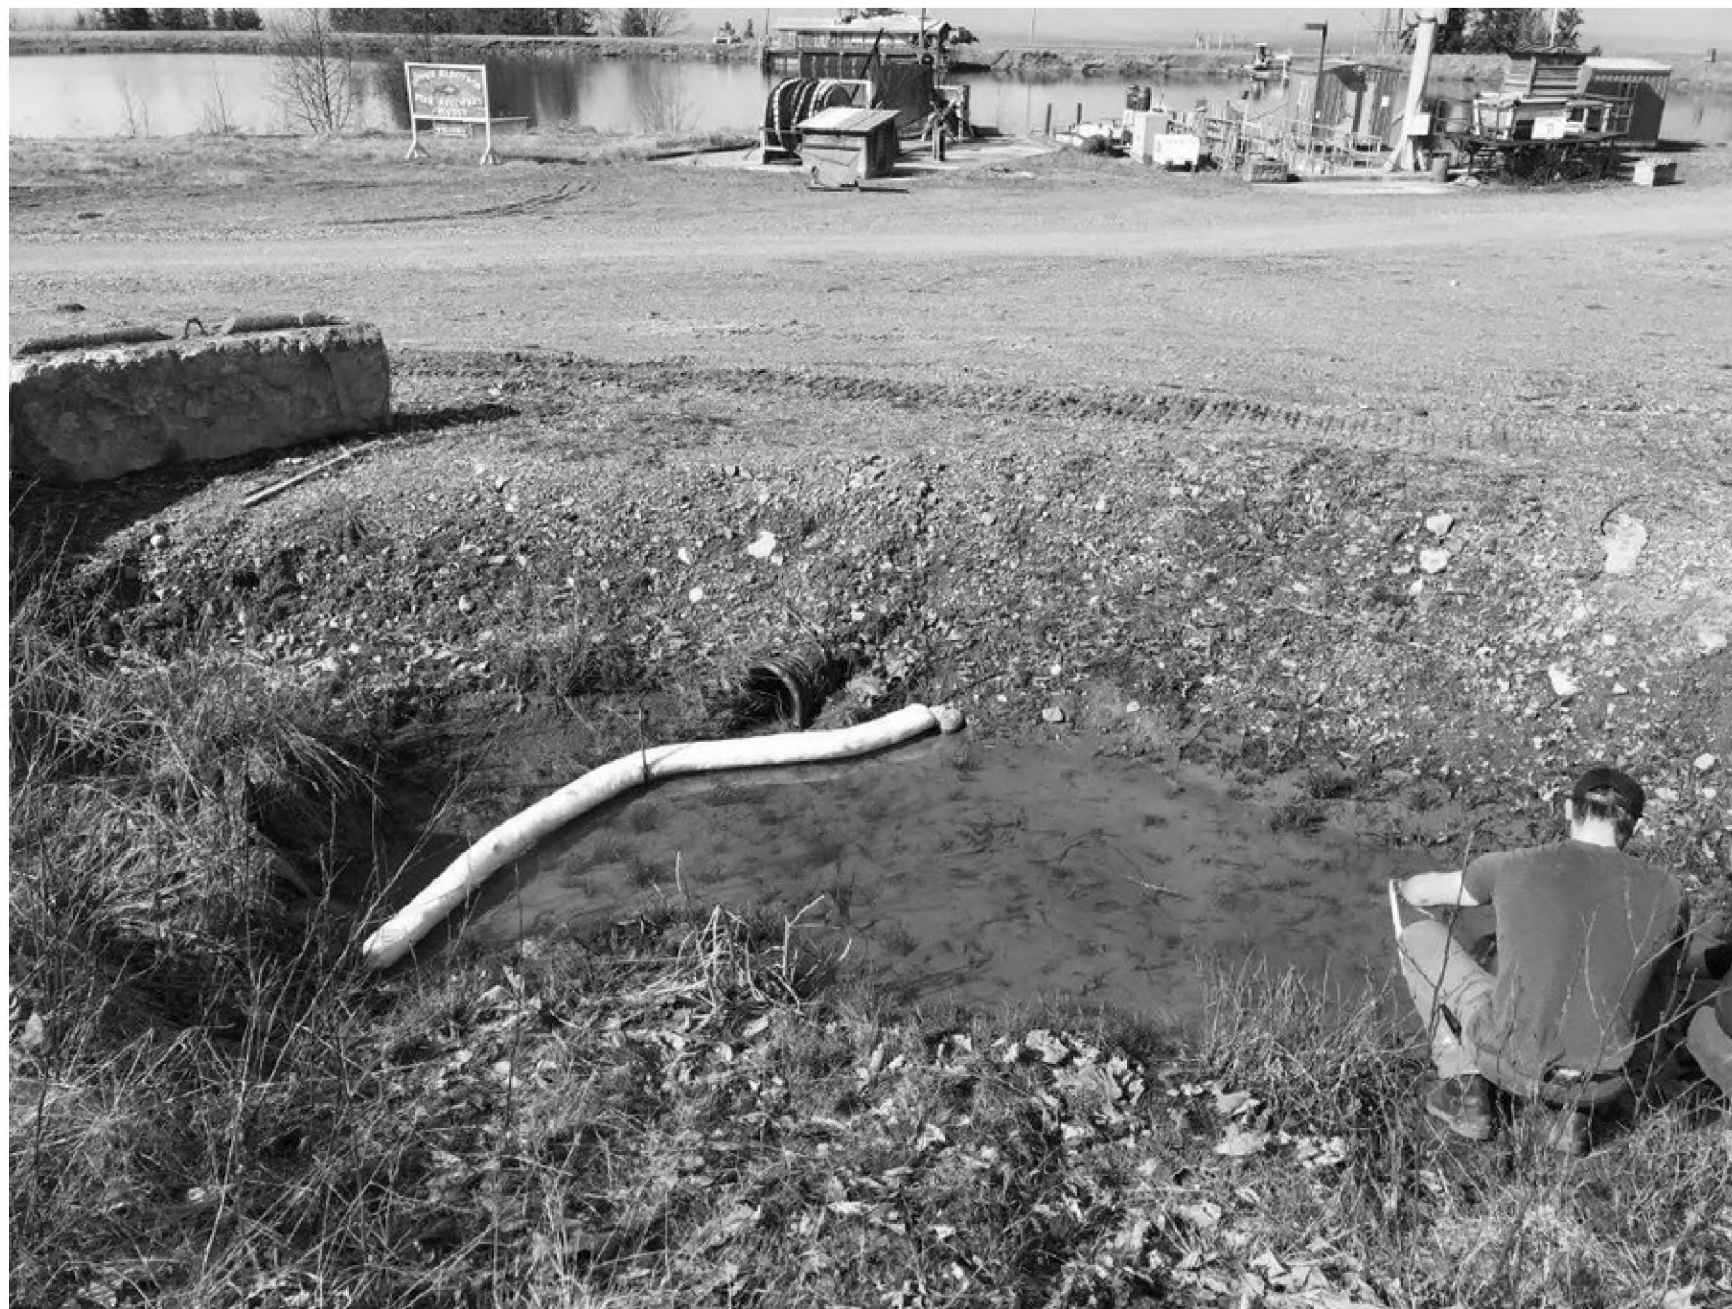
Photo 16

Photo Description: Forebay area – Precautionary oil absorbent booms placed in the stormwater conveyances

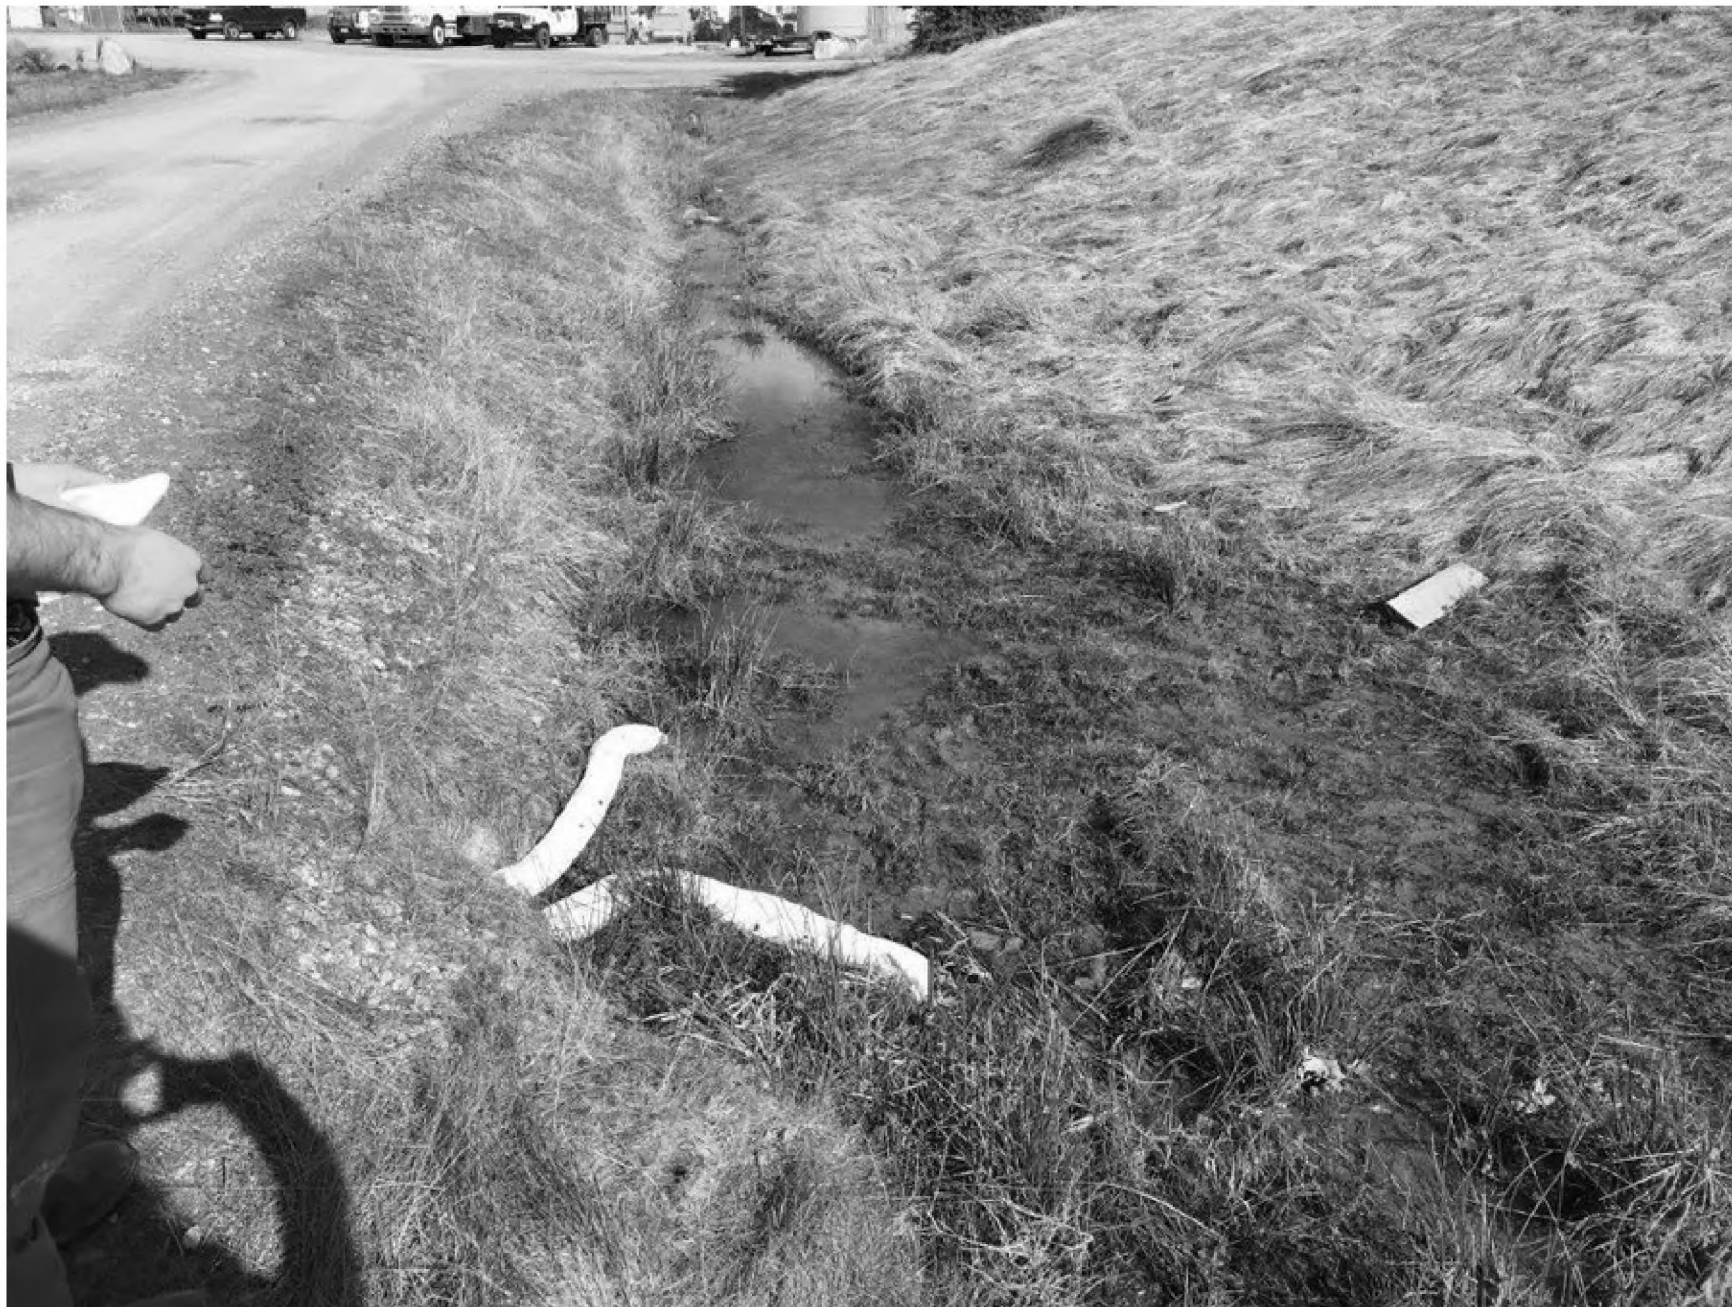
Photo 17

Photo Description: Forebay area – Precautionary oil absorbent booms placed in the stormwater conveyances

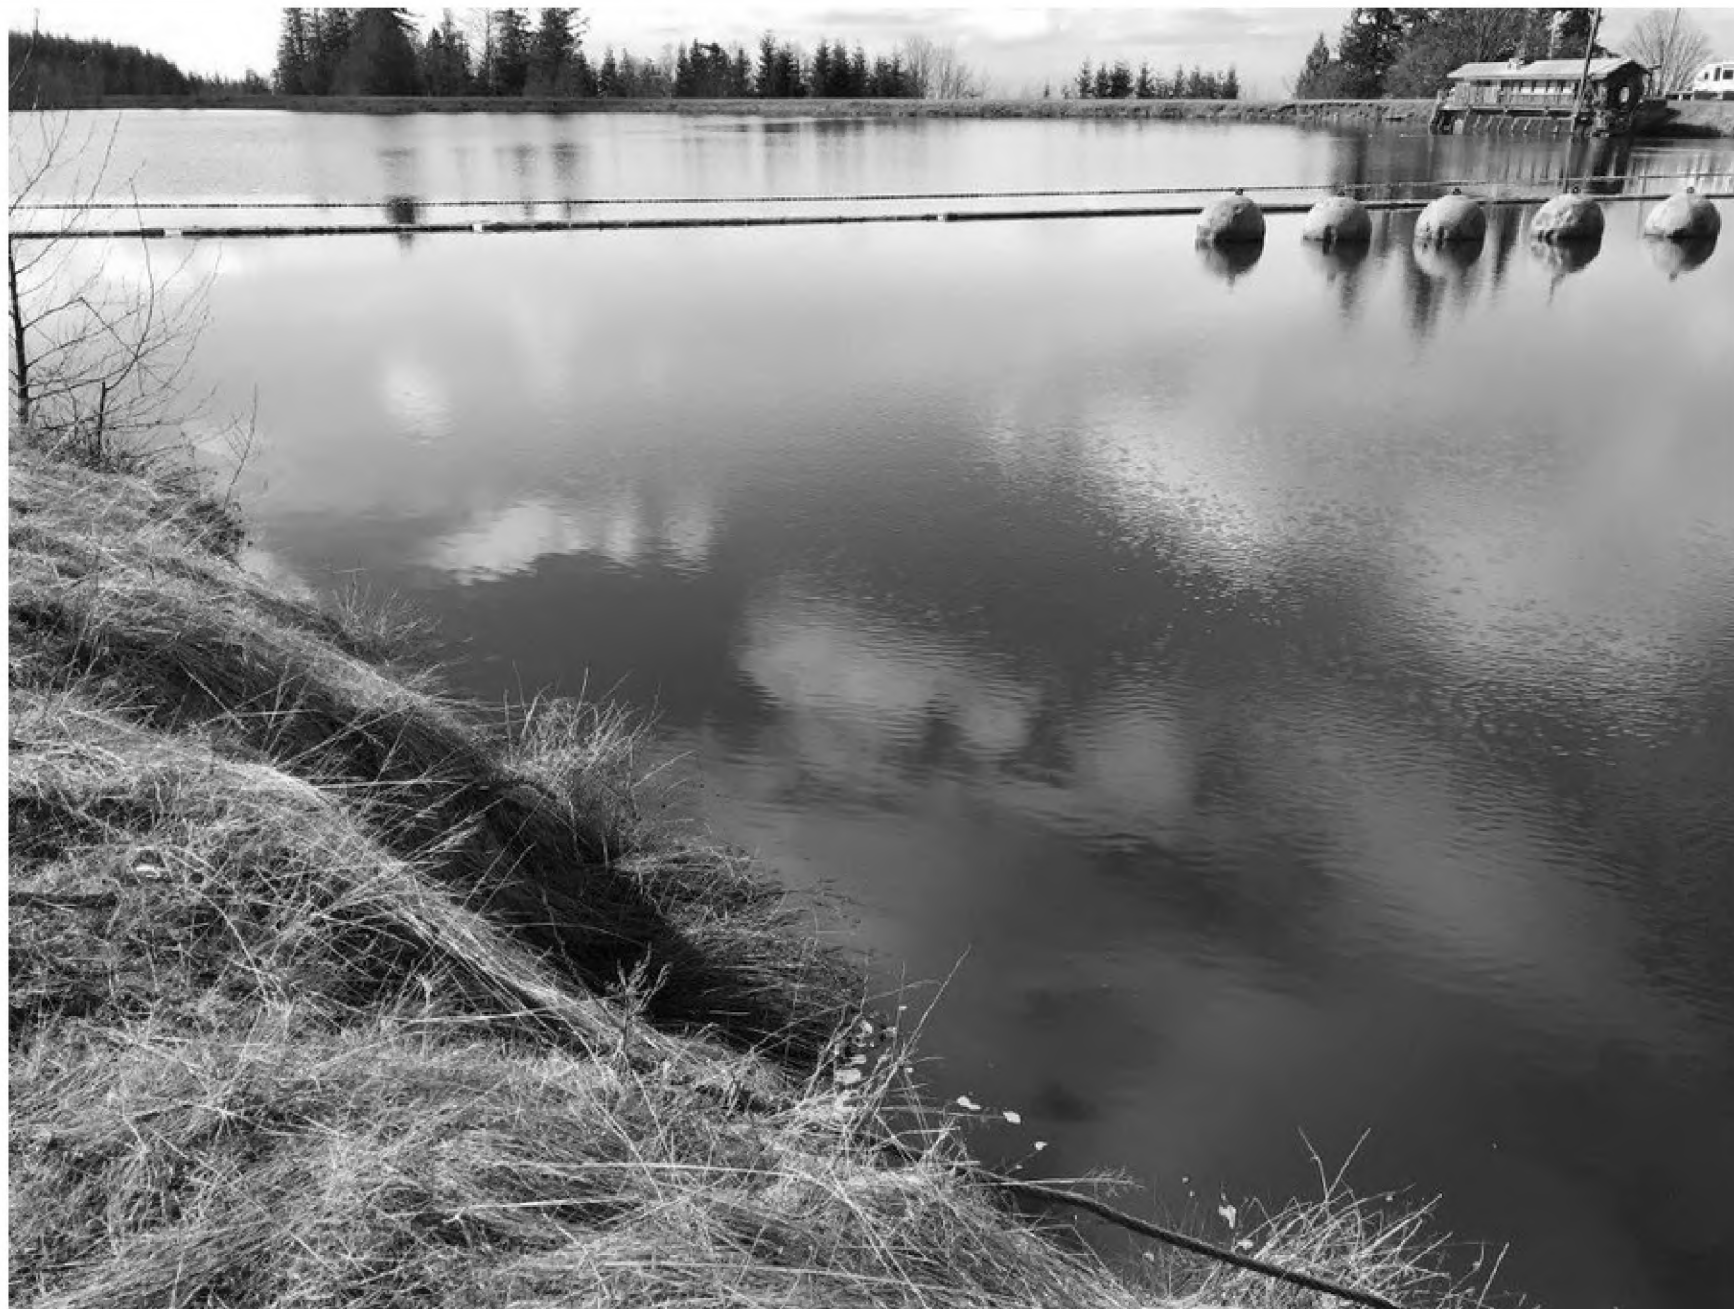
Photo 18

Photo Description: Stormwater conveyance ditch discharge location at the forebay (bottom center of photo)

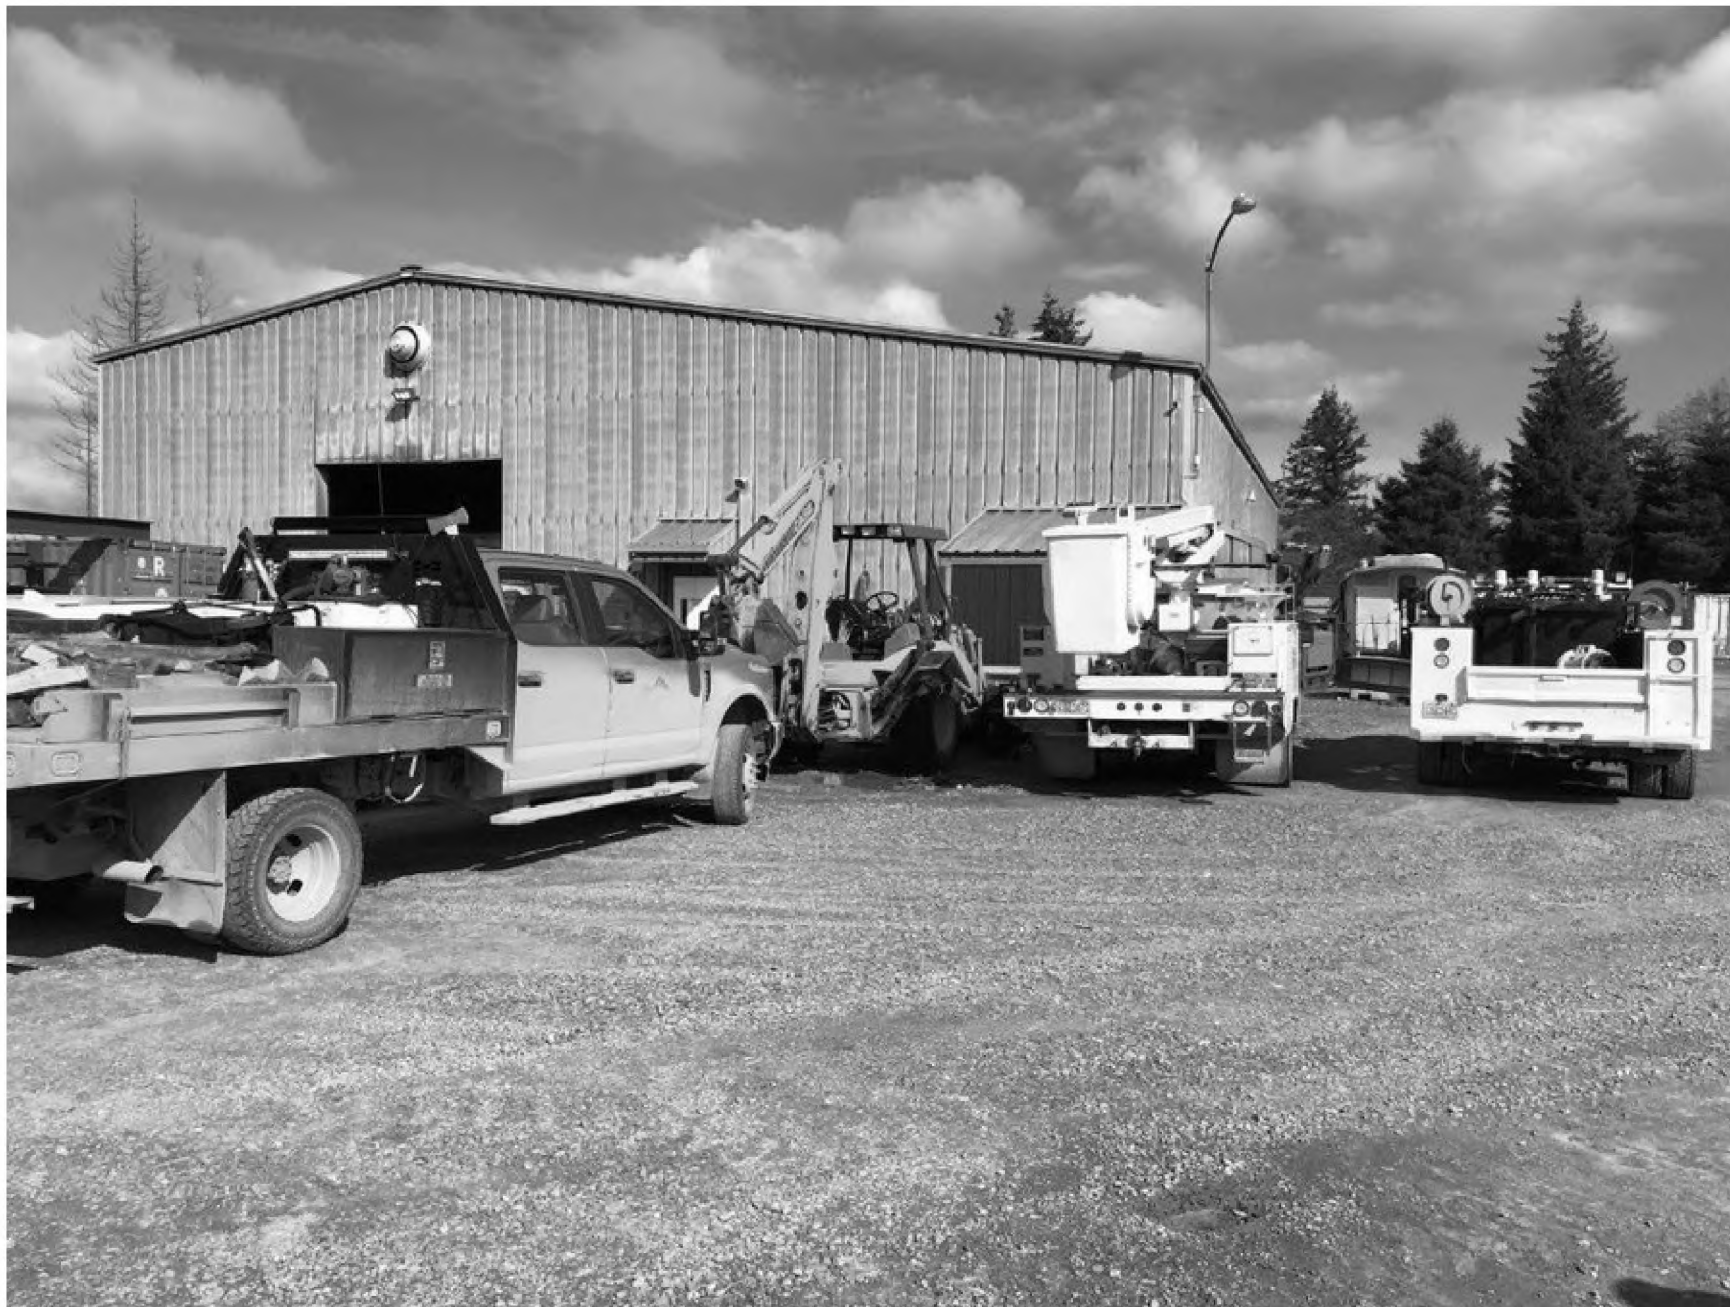
Photo 19

Photo Description: Forebay area - Maintenance shed
